# Access Compliance Report Public Rights-of-Way (Curb Ramps)

Main Street: **RODEO\_DR** Cross Street: **TINA\_WAY** Location: **NE**

ADA ID: **RPRK210921183030** Ramp Type: **Type 1 - Perpendicular Diagonal Initial Pass/Fail: Pass** Overall Compliance: **No** Severity Score: **0**

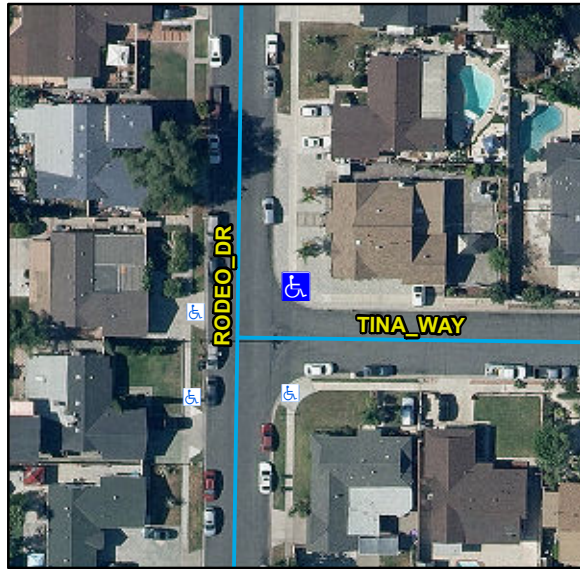
| Compliance | Description | Data | Compliance | Description | Data |
|---|---|---|---|---|---|
| <b>No</b> | Gutter Cross Slope (%) | <b>6</b> | | | |

**Remove & Replace Landing. Remove & Replace Gutter.**

**R304.2.1, R304.5.3, STD 1115**
