# Access Compliance Report Public Rights-of-Way (Curb Ramps)

Main Street: HARLE\_AVE Cross Street: RODEO\_DR Location: SE

ADA ID: RPRK210922105516 Ramp Type: Type 1 - Perpendicular Diagonal Initial Pass/Fail: Fail Overall Compliance: No Severity Score: 15

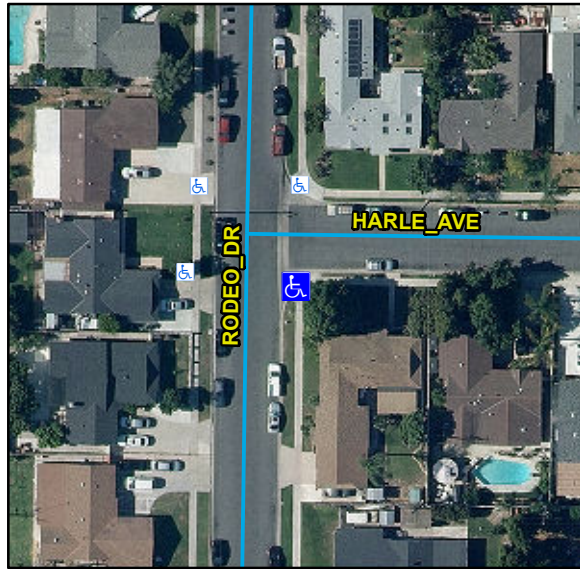
| Compliance | Description | Data | Compliance | Description | Data |
|---|---|---|---|---|---|
| No | Ramp Run Slope (%) | 9 | N/A | Flare Slope LT (%) | N/A |
| N/A | Gutter Ponding | N/A | No | Curb Slope | 9.6 |

**Remove & Replace Curb Ramp With Two New Directional Ramps or Equivalent.**

**R304.2.2, R204.3, STD 1115**
