# Access Compliance Report Public Rights-of-Way (Curb Ramps)

Main Street: CERRITOS\_AVE Cross Street: RODEO\_DR Location: SE

ADA ID: RPRK210922110843 Ramp Type: Type 1 - Perpendicular Diagonal Initial Pass/Fail: Pass Overall Compliance: No Severity Score: 21

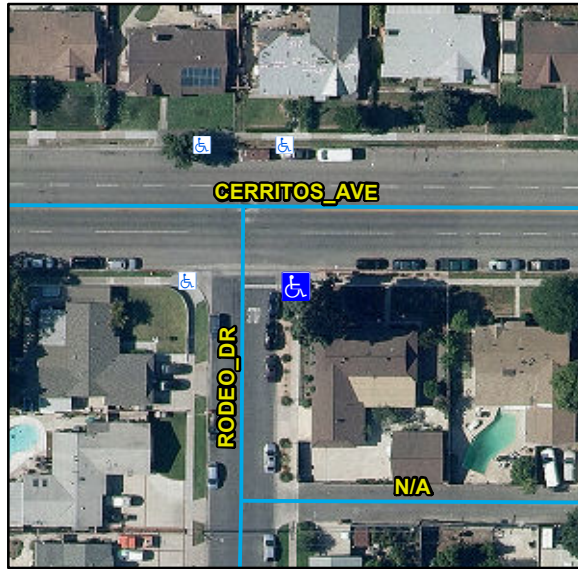
| Compliance | Description | Data | Compliance | Description | Data |
|---|---|---|---|---|---|
| No | Landing Run Slope (%) | 8.3 | N/A | Flare Traversable RT | No |
| No | Landing Cross Slope (%) | 2.3 | No | DWS Provided | No |
| N/A | Landing Movement Obstructed? | Yes | N/A | DWS Contrast | N/A |
| | Landing Movement Type | Fence | N/A | DWS Length (in) | N/A |
| No | Gutter Ponding | Yes | No | Curb Slope | 9 |

Remove & Replace Curb Ramp With Two New Directional Ramps or Equivalent.
