# Access Compliance Report Public Rights-of-Way (Curb Ramps)

Main Street: **RODEO\_DR** Cross Street: **CERRITOS\_AVE** Location: **SW**

ADA ID: **RPRK210922111357** Ramp Type: **Type 1 - Perpendicular Diagonal** Initial Pass/Fail: **Fail** Overall Compliance: **No** Severity Score: **15**

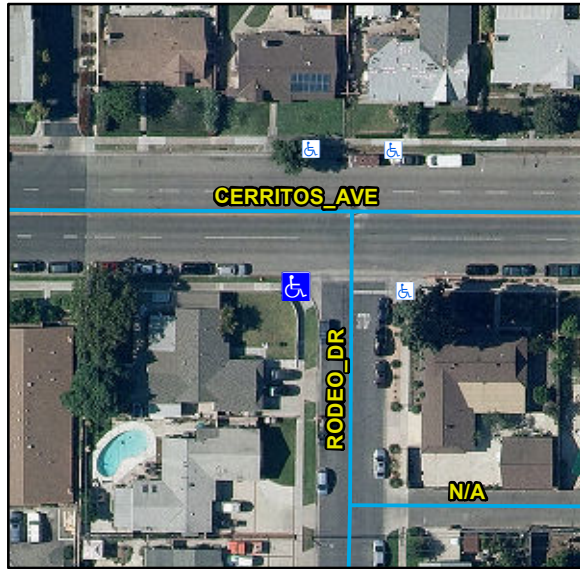
| Compliance | Description | Data | Compliance | Description | Data |
|---|---|---|---|---|---|
| <b>No</b> | Ramp Run Slope (%) | <b>9.3</b> | <b>N/A</b> | Flare Slope LT (%) | <b>N/A</b> |

**Remove & Replace Curb Ramp With Two New Directional Ramps or Equivalent.**

**R304.2.2, STD 1115**
