# Access Compliance Report Public Rights-of-Way (Curb Ramps)

Main Street: CERRITOS\_AVE Cross Street: S\_GARZA\_ST Location: NW

ADA ID: RPRK210922112428 Ramp Type: Type 1 - Perpendicular Diagonal Initial Pass/Fail: Pass Overall Compliance: No Severity Score: 22

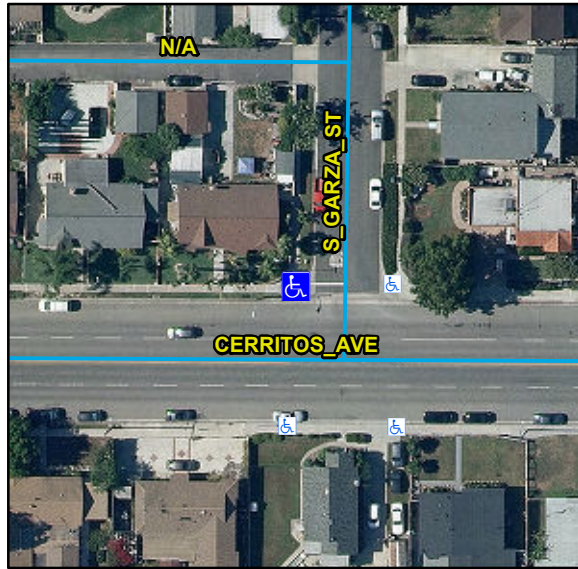
| Compliance | Description | Data | Compliance | Description | Data |
|---|---|---|---|---|---|
| No | Landing Cross Slope (%) | 2.8 | No | DWS Provided | No |
| No | Gutter Run Slope (%) | 6.7 | | Road Cross Slope (%) | 2.5 |
| No | Gutter Cross Slope (%) | 2.4 | | | |

Remove & Replace Curb Ramp With Two New Directional Ramps or Equivalent. Remove & Replace Gutter.
