# Access Compliance Report Public Rights-of-Way (Curb Ramps)

Main Street: PACIFIC\_AVE Cross Street: HARCOURT\_AVE Location: NW

ADA ID: RPRK210922115425 Ramp Type: Type 1 - Perpendicular Diagonal Initial Pass/Fail: Fail Overall Compliance: No Severity Score: 32

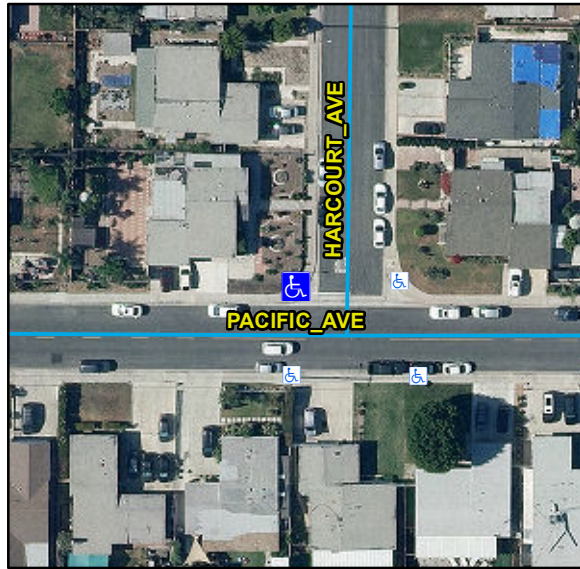
| Compliance | Description | Data | Compliance | Description | Data |
|---|---|---|---|---|---|
| No | Ramp Run Slope (%) | 13.1 | N/A | Flare Slope LT (%) | N/A |
| No | Ramp Cross Slope (%) | 2.5 | N/A | Flare Traversable LT | N/A |
| No | Gutter Lip Height (in) | 0.5 | | Road Run Slope (%) | 1 |

Remove & Replace Curb Ramp With Two New Directional Ramps or Equivalent.

R304.2.2, R304.5.3, R302.7.2, STD 1115
