# Access Compliance Report Public Rights-of-Way (Curb Ramps)

Main Street: HARCOURT\_AVE Cross Street: PACIFIC\_AVE Location: NE

ADA ID: RPRK210922115957 Ramp Type: Type 1 - Perpendicular Diagonal Initial Pass/Fail: Fail Overall Compliance: No Severity Score: 16

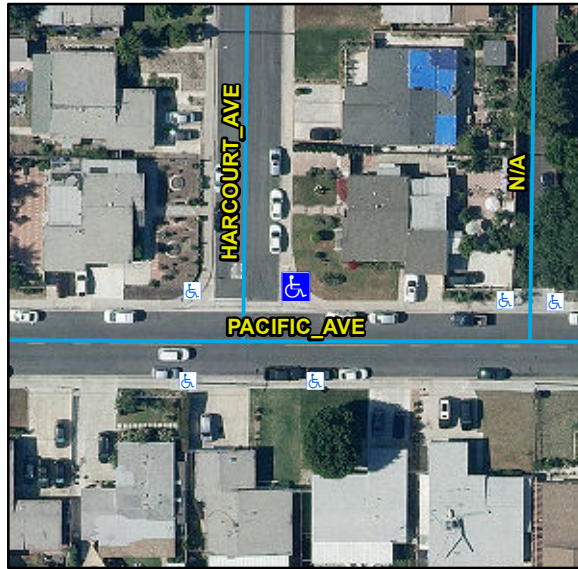
| Compliance | Description | Data | Compliance | Description | Data |
|---|---|---|---|---|---|
| No | Ramp Run Slope (%) | 11.9 | N/A | Flare Slope LT (%) | N/A |
| No | Ramp Cross Slope (%) | 2.2 | N/A | Flare Traversable LT | N/A |
| No | Gutter Lip Height (in) | 0.5 | | Road Run Slope (%) | 1.3 |

Remove & Replace Curb Ramp With Two New Directional Ramps or Equivalent. Grind Gutter Lip.

R304.2.2, R304.5.3, R302.7.2, STD 1115
