# Access Compliance Report Public Rights-of-Way (Curb Ramps)

Main Street: **DESSER\_LN** Cross Street: **PACIFIC\_AVE** Location: **NE**

ADA ID: **RPRK210922120806** Ramp Type: **Type 1 - Perpendicular Diagonal Initial Pass/Fail: Fail** Overall Compliance: **No** Severity Score: **15**

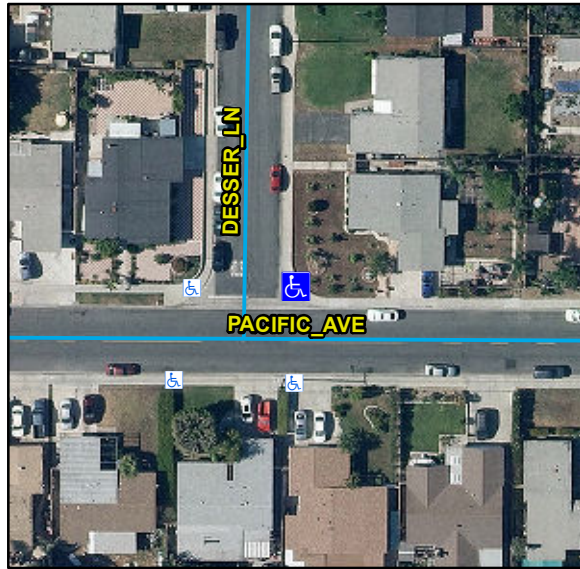
| Compliance | Description | Data | Compliance | Description | Data |
|---|---|---|---|---|---|
| <b>No</b> | Ramp Run Slope (%) | <b>11.7</b> | <b>N/A</b> | Flare Slope LT (%) | <b>N/A</b> |
| <b>No</b> | Gutter Lip Height (in) | <b>0.5</b> | | Road Run Slope (%) | <b>0.3</b> |

**Remove & Replace Curb Ramp With Two New Directional Ramps or Equivalent.**

**R304.2.2, R302.7.2, STD 1115**
