# Access Compliance Report Public Rights-of-Way (Curb Ramps)

Main Street: PACIFIC\_AVE Cross Street: DESSER\_LN Location: NW

ADA ID: RPRK210922121221 Ramp Type: Type 1 - Perpendicular Diagonal Initial Pass/Fail: Pass Overall Compliance: No Severity Score: 22

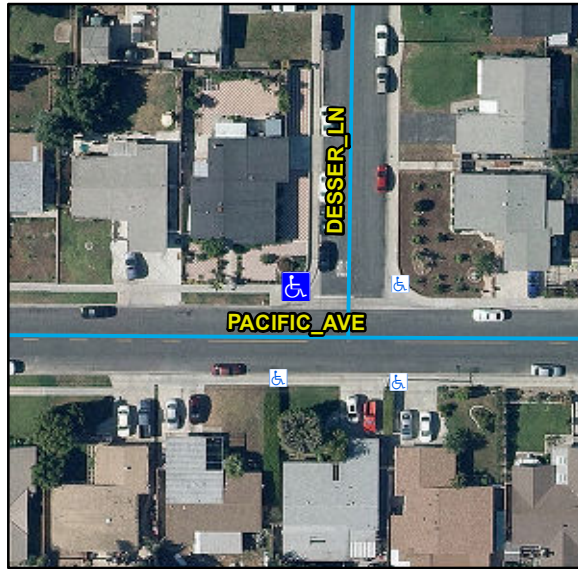
| Compliance | Description | Data | Compliance | Description | Data |
|---|---|---|---|---|---|
| No | Landing Width (in) | N/A | No | Flare Slope RT (%) | 11.3 |
| No | Landing Cross Slope (%) | N/A | No | DWS Provided | No |
| Yes | Gutter Ponding | No | No | Curb Slope | 9.2 |

Remove & Replace Curb Ramp With Two New Directional Ramps or Equivalent.
