# Access Compliance Report Public Rights-of-Way (Curb Ramps)

Main Street: GILBERT\_ST Cross Street: PACIFIC\_AVE Location: SW

ADA ID: RPRK210922121821 Ramp Type: Type 4 - Parallel Initial Pass/Fail: Pass Overall Compliance: No Severity Score: 30

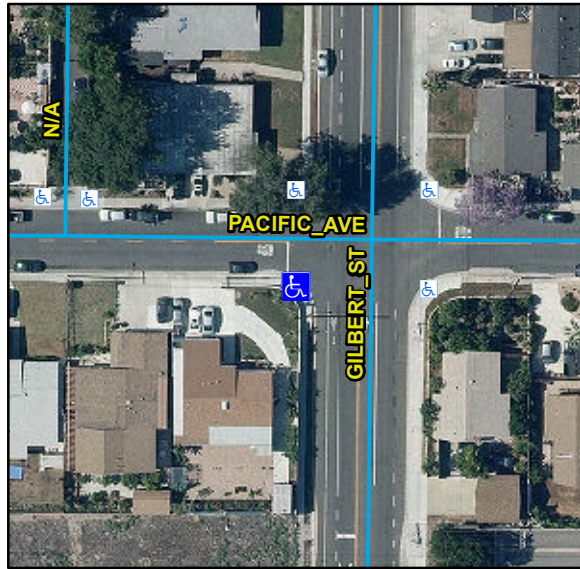
| Compliance | Description | Data | Compliance | Description | Data |
|---|---|---|---|---|---|
| No | Ramp Cross Slope LT (%) | 7.6 | Yes | Ramp Cross Slope RT (%) | 1.4 |
| Yes | Gutter Ponding | No | No | Curb Slope | 9.6 |

Remove & Replace Curb Slope. Remove & Replace Sidewalk. Utility Present.

R304.2.2, R304.5.3, STD 1115
