# Access Compliance Report Public Rights-of-Way (Curb Ramps)

Main Street: PACIFIC\_AVE Cross Street: GILBERT\_ST Location: NW

ADA ID: RPRK210922122357 Ramp Type: Type 4 - Parallel Initial Pass/Fail: Fail Overall Compliance: No Severity Score: 15

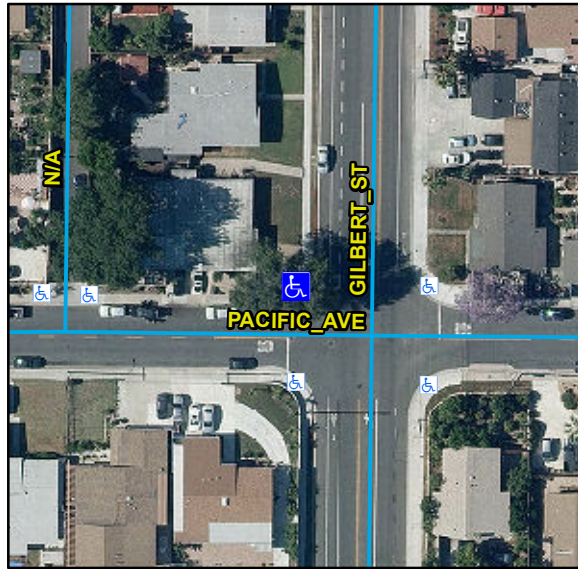
| Compliance | Description | Data | Compliance | Description | Data |
|---|---|---|---|---|---|
| Yes | Ramp Run Slope LT (%) | 6.3 | No | Ramp Run Slope RT (%) | 9.3 |

**Remove & Replace Curb Ramp With Two New Directional Ramps or Equivalent.**

**R304.3.2, STD 1115**
