# Access Compliance Report Public Rights-of-Way (Curb Ramps)

Main Street: PACIFIC\_AVE Cross Street: LARRY\_DR Location: NW

ADA ID: RPRK210922122942 Ramp Type: Type 1 - Perpendicular Diagonal Initial Pass/Fail: Fail Overall Compliance: No Severity Score: 30

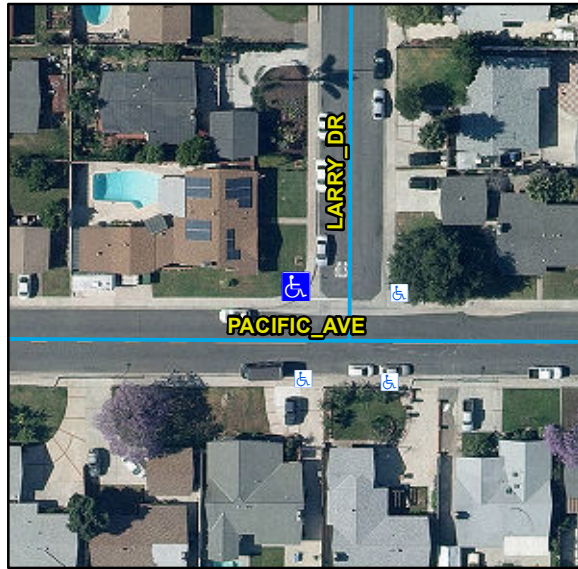
| Compliance | Description | Data | Compliance | Description | Data |
|---|---|---|---|---|---|
| No | Ramp Run Slope (%) | 14.1 | N/A | Flare Slope LT (%) | N/A |

Remove & Replace Curb Ramp With Two New Directional Ramps or Equivalent.

R304.2.2, STD 1115
