# Access Compliance Report Public Rights-of-Way (Curb Ramps)

Main Street: LARRY\_DR Cross Street: PACIFIC\_AVE Location: NE

ADA ID: RPRK210922123358 Ramp Type: Type 1 - Perpendicular Diagonal Initial Pass/Fail: Fail Overall Compliance: No Severity Score: 30

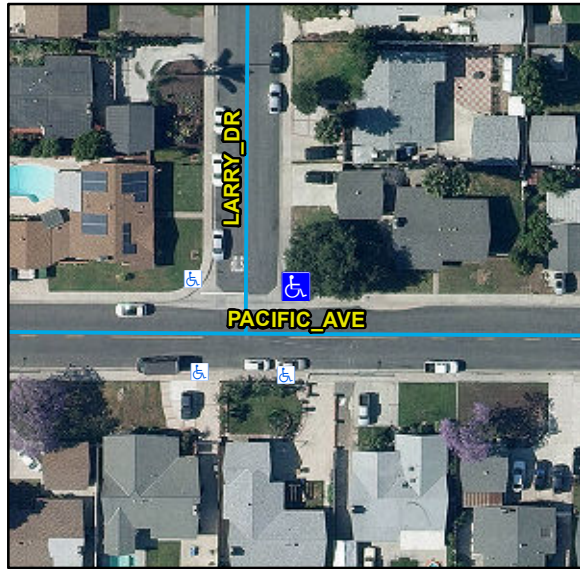
| Compliance | Description | Data | Compliance | Description | Data |
|---|---|---|---|---|---|
| No | Ramp Run Slope (%) | 12.5 | N/A | Flare Slope LT (%) | N/A |

**Remove & Replace Curb Ramp With Two New Directional Ramps or Equivalent.**

**R304.2.2, STD 1115**
