# Access Compliance Report Public Rights-of-Way (Curb Ramps)

Main Street: PACIFIC\_AVE Cross Street: THOMAS\_DR Location: NW

ADA ID: RPRK210922123857 Ramp Type: Type 1 - Perpendicular Diagonal Initial Pass/Fail: Fail Overall Compliance: No Severity Score: 32

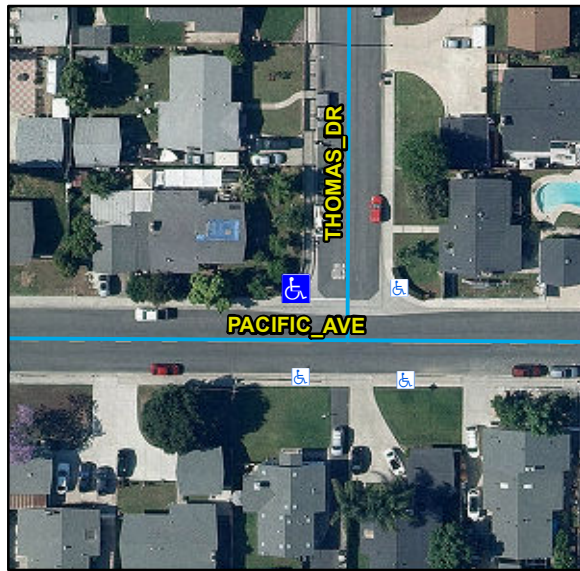
| Compliance | Description | Data | Compliance | Description | Data |
|---|---|---|---|---|---|
| No | Ramp Run Slope (%) | 14.2 | N/A | Flare Slope LT (%) | N/A |
| No | Ramp Cross Slope (%) | 3.4 | N/A | Flare Traversable LT | N/A |

Remove & Replace Curb Ramp With Two New Directional Ramps or Equivalent.

R304.2.2, R304.5.3, STD 1115
