# Access Compliance Report Public Rights-of-Way (Curb Ramps)

Main Street: THOMAS\_DR Cross Street: PACIFIC\_AVE Location: NE

ADA ID: RPRK210922124128 Ramp Type: Type 1 - Perpendicular Diagonal Initial Pass/Fail: Pass Overall Compliance: No Severity Score: 25

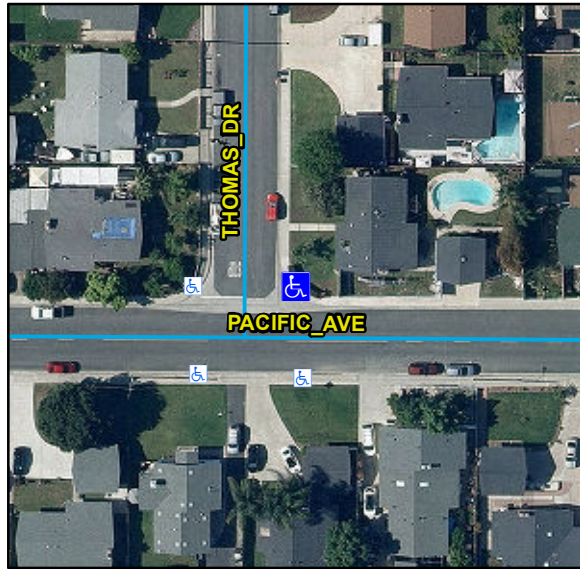
| Compliance | Description | Data | Compliance | Description | Data |
|---|---|---|---|---|---|
| Yes | Ramp Run Slope (%) | 4.3 | No | Flare Slope LT (%) | 12.2 |
| No | Landing Width (in) | N/A | No | Flare Slope RT (%) | 11.8 |
| No | Landing Cross Slope (%) | N/A | No | DWS Provided | No |
| N/A | Landing Movement Obstructed? | Yes | N/A | DWS Contrast | N/A |
| | Landing Movement Type | Bushes | N/A | DWS Length (in) | N/A |

Remove & Replace Curb Ramp With Two New Directional Ramps or Equivalent.
