# Access Compliance Report Public Rights-of-Way (Curb Ramps)

Main Street: HEDLUND\_DR Cross Street: PACIFIC\_AVE Location: NE

ADA ID: RPRK210922124703 Ramp Type: Type 1 - Perpendicular Diagonal Initial Pass/Fail: Fail Overall Compliance: No Severity Score: 30

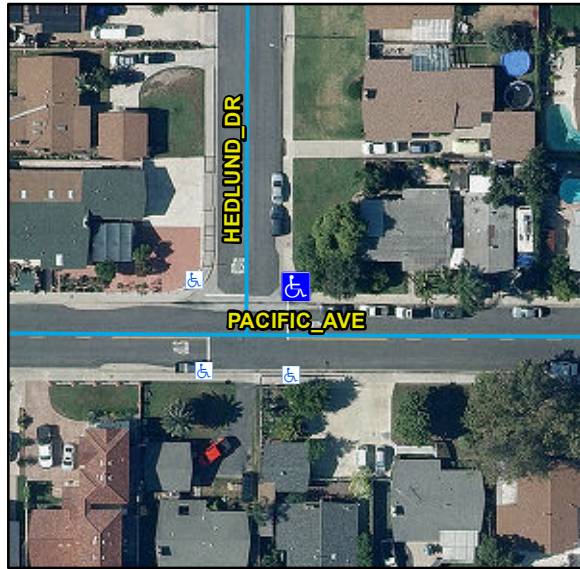
| Compliance | Description | Data | Compliance | Description | Data |
|---|---|---|---|---|---|
| No | Ramp Run Slope (%) | 15.7 | N/A | Flare Slope LT (%) | N/A |

Remove & Replace Curb Ramp With Two New Directional Ramps or Equivalent.

R304.2.2, STD 1115
