# Access Compliance Report Public Rights-of-Way (Curb Ramps)

Main Street: PACIFIC\_AVE Cross Street: HEDLUND\_DR Location: NW

ADA ID: RPRK210922124927 Ramp Type: Type 1 - Perpendicular Diagonal Initial Pass/Fail: Fail Overall Compliance: No Severity Score: 30

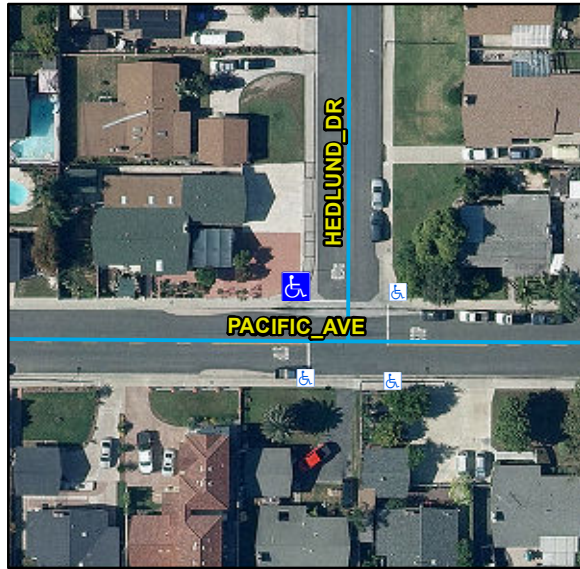
| Compliance | Description | Data | Compliance | Description | Data |
|---|---|---|---|---|---|
| No | Ramp Run Slope (%) | 13.5 | N/A | Flare Slope LT (%) | N/A |

**Remove & Replace Curb Ramp With Two New Directional Ramps or Equivalent.**

**R304.2.2, STD 1115**
