# Access Compliance Report Public Rights-of-Way (Curb Ramps)

Main Street: PACIFIC\_AVE Cross Street: CREW\_DR Location: NW

ADA ID: RPRK210922125641 Ramp Type: Type 1 - Perpendicular Diagonal Initial Pass/Fail: Fail Overall Compliance: No Severity Score: 30

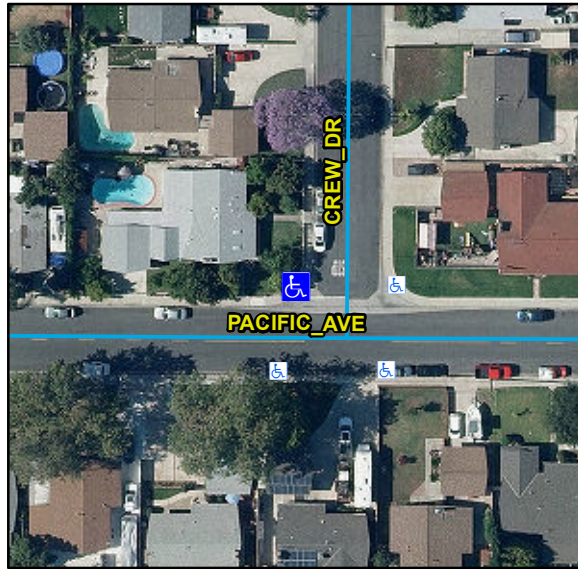
| Compliance | Description | Data | Compliance | Description | Data |
|---|---|---|---|---|---|
| No | Ramp Run Slope (%) | 14 | N/A | Flare Slope LT (%) | N/A |
| No | Gutter Lip Height (in) | 0.5 | | Road Run Slope (%) | 1.3 |

**Remove & Replace Curb Ramp With Two New Directional Ramps or Equivalent. Grind Gutter Lip.**
