# Access Compliance Report Public Rights-of-Way (Curb Ramps)

Main Street: CREW\_DR Cross Street: PACIFIC\_AVE Location: NE

ADA ID: RPRK210922130039 Ramp Type: Type 1 - Perpendicular Diagonal Initial Pass/Fail: Fail Overall Compliance: No Severity Score: 30

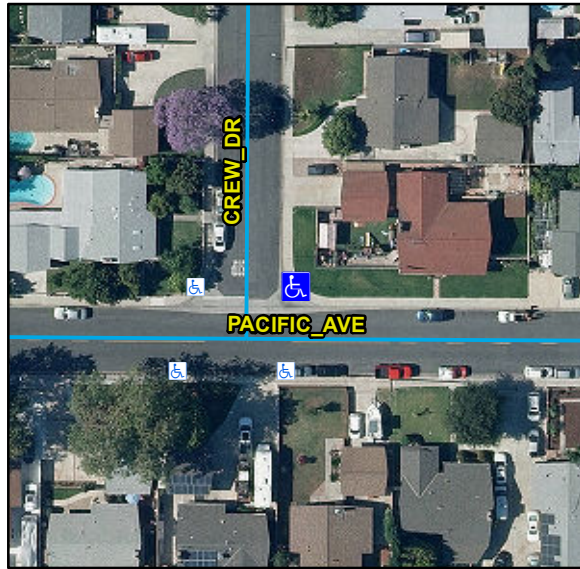
| Compliance | Description | Data | Compliance | Description | Data |
|---|---|---|---|---|---|
| No | Ramp Run Slope (%) | 12.2 | N/A | Flare Slope LT (%) | N/A |

**Remove & Replace Curb Ramp With Two New Directional Ramps or Equivalent.**

**R304.2.2, STD 1115**
