# Access Compliance Report Public Rights-of-Way (Curb Ramps)

Main Street: DIXIE\_DR Cross Street: PACIFIC\_AVE Location: NE

ADA ID: RPRK210922130706 Ramp Type: Type 1 - Perpendicular Diagonal Initial Pass/Fail: Fail Overall Compliance: No Severity Score: 32

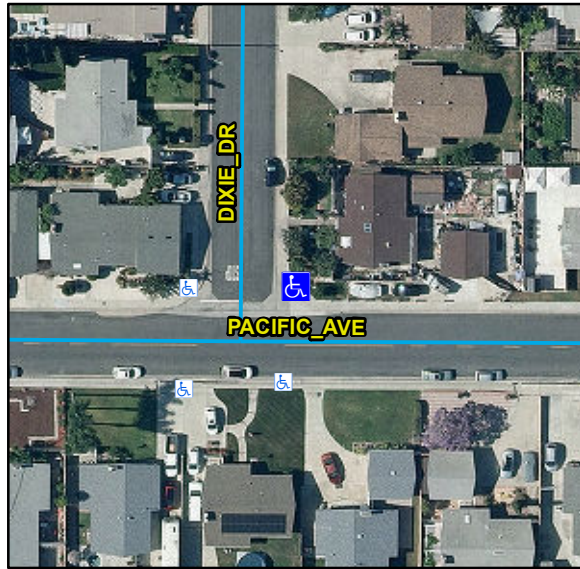
| Compliance | Description | Data | Compliance | Description | Data |
|---|---|---|---|---|---|
| No | Ramp Run Slope (%) | 13.5 | N/A | Flare Slope LT (%) | N/A |
| No | Ramp Cross Slope (%) | 2.5 | N/A | Flare Traversable LT | N/A |

**Remove & Replace Curb Ramp With Two New Directional Ramps or Equivalent.**

**R304.2.2, R304.5.3, STD 1115**
