# Access Compliance Report Public Rights-of-Way (Curb Ramps)

Main Street: PACIFIC\_AVE Cross Street: DIXIE\_DR Location: NW

ADA ID: RPRK210922131056 Ramp Type: Type 1 - Perpendicular Diagonal Initial Pass/Fail: Fail Overall Compliance: No Severity Score: 30

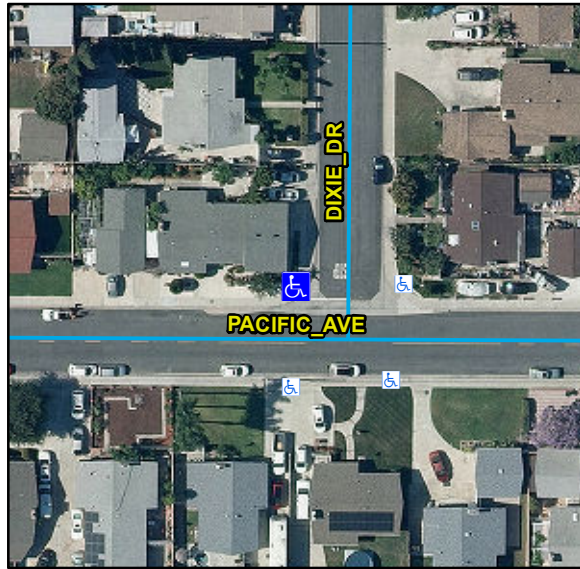
| Compliance | Description | Data | Compliance | Description | Data |
|---|---|---|---|---|---|
| No | Ramp Run Slope (%) | 15.3 | N/A | Flare Slope LT (%) | N/A |

Remove & Replace Curb Ramp With Two New Directional Ramps or Equivalent.

R304.2.2, STD 1115
