# Access Compliance Report Public Rights-of-Way (Curb Ramps)

Main Street: PACIFIC\_AVE Cross Street: CHAMBERLAIN\_AVE Location: NW

ADA ID: RPRK210922131556 Ramp Type: Type 1 - Perpendicular Diagonal Initial Pass/Fail: Fail Overall Compliance: No Severity Score: 30

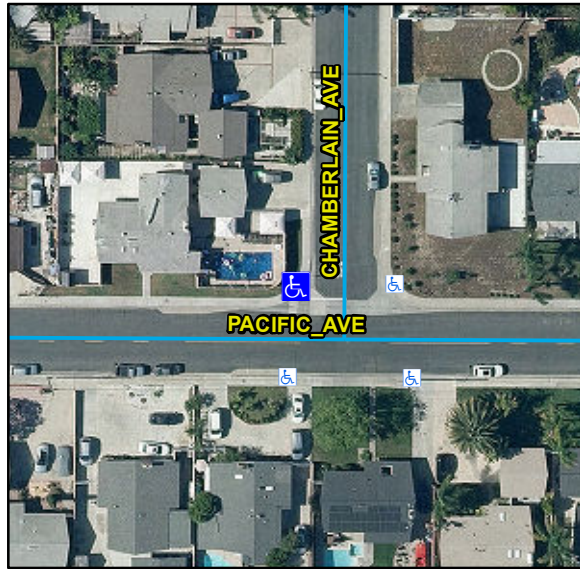
| Compliance | Description | Data | Compliance | Description | Data |
|---|---|---|---|---|---|
| No | Ramp Run Slope (%) | 15.2 | N/A | Flare Slope LT (%) | N/A |

Remove & Replace Curb Ramp With Two New Directional Ramps or Equivalent.

R304.2.2, STD 1115
