# Access Compliance Report Public Rights-of-Way (Curb Ramps)

Main Street: CHAMBERLAIN\_AVE Cross Street: PACIFIC\_AVE Location: NE

ADA ID: RPRK210922131833 Ramp Type: Type 1 - Perpendicular Diagonal Initial Pass/Fail: Fail Overall Compliance: No Severity Score: 30

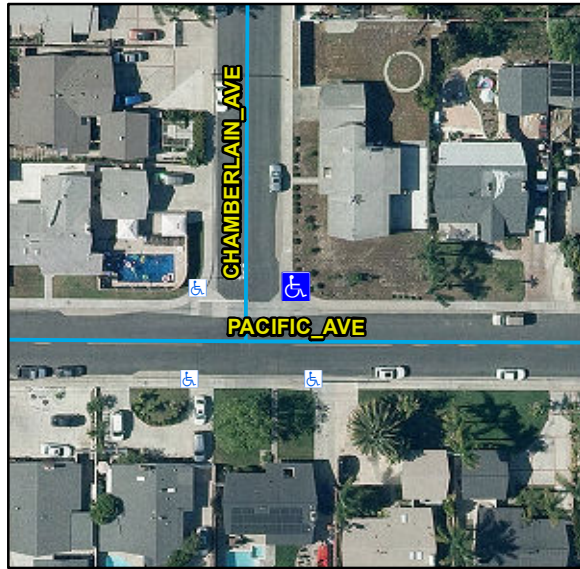
| Compliance | Description | Data | Compliance | Description | Data |
|---|---|---|---|---|---|
| No | Ramp Run Slope (%) | 14.7 | N/A | Flare Slope LT (%) | N/A |

Remove & Replace Curb Ramp With Two New Directional Ramps or Equivalent.

R304.2.2, STD 1115
