# Access Compliance Report Public Rights-of-Way (Curb Ramps)

Main Street: CHAMBERLAIN\_AVE Cross Street: CRIS\_AVE Location: NE

ADA ID: RPRK210922132425 Ramp Type: Type 1 - Perpendicular Diagonal Initial Pass/Fail: Fail Overall Compliance: No Severity Score: 16

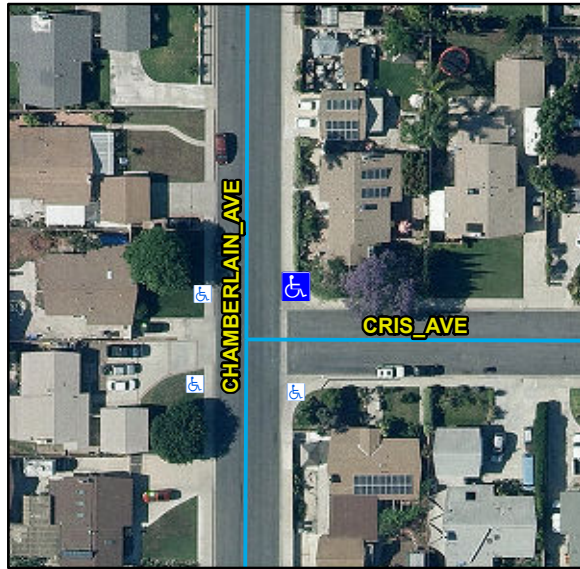
| Compliance | Description | Data | Compliance | Description | Data |
|---|---|---|---|---|---|
| No | Ramp Run Slope (%) | 11.1 | N/A | Flare Slope LT (%) | N/A |

**Remove & Replace Curb Ramp With Two New Directional Ramps or Equivalent.**

**R304.2.2, STD 1115**
