# Access Compliance Report Public Rights-of-Way (Curb Ramps)

Main Street: CRIS\_AVE Cross Street: CHAMBERLAIN\_AVE Location: SE

ADA ID: RPRK210922132656 Ramp Type: Type 1 - Perpendicular Diagonal Initial Pass/Fail: Fail Overall Compliance: No Severity Score: 32

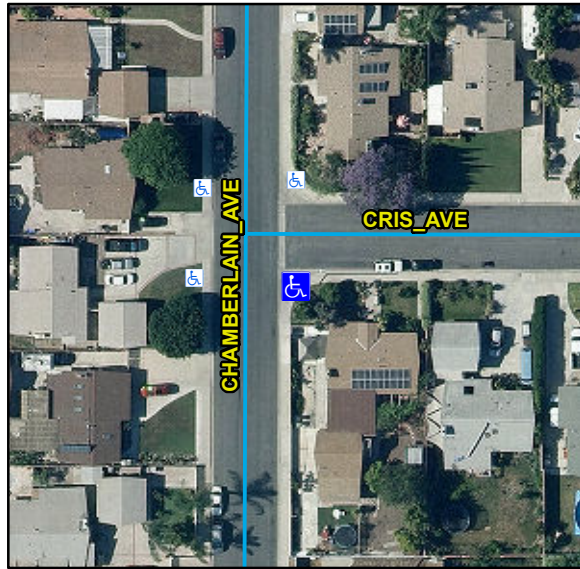
| Compliance | Description | Data | Compliance | Description | Data |
|---|---|---|---|---|---|
| No | Ramp Run Slope (%) | 13.9 | N/A | Flare Slope LT (%) | N/A |

Remove & Replace Curb Ramp With Two New Directional Ramps or Equivalent.

R304.2.2, STD 1115
