# Access Compliance Report Public Rights-of-Way (Curb Ramps)

Main Street: HARLE\_AVE Cross Street: CHAMBERLAIN\_AVE Location: NW

ADA ID: RPRK210922134213 Ramp Type: Type 1 - Perpendicular Diagonal Initial Pass/Fail: Fail Overall Compliance: No Severity Score: 32

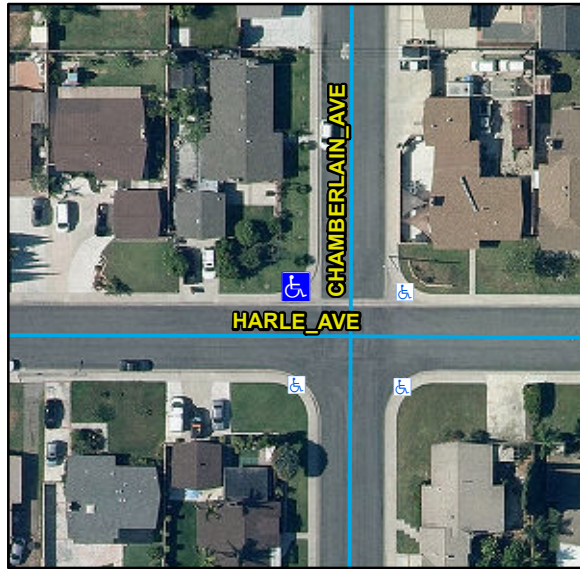
| Compliance | Description | Data | Compliance | Description | Data |
|---|---|---|---|---|---|
| No | Ramp Run Slope (%) | 13.3 | N/A | Flare Slope LT (%) | N/A |

**Remove & Replace Curb Ramp With Two New Directional Ramps or Equivalent.**

**R304.2.2, STD 1115**
