# Access Compliance Report Public Rights-of-Way (Curb Ramps)

| Main Street: CHAMBERLAIN_AVE | | Cross Street: HARLE_AVE | | Location: | NE |
| ADA ID: RPRK210922134429 | Ramp Type:Type 1 - Perpendicular Diagonal Initial Pass/Fail: Fail | | Overall Compliance: No | Severity Score: | 32 |

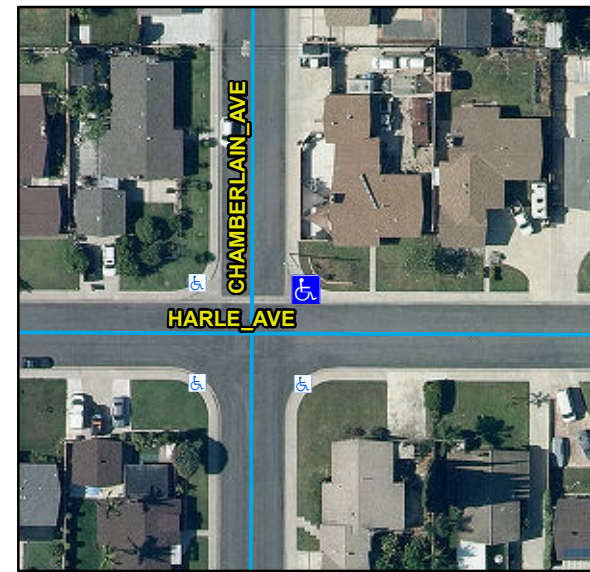
| Compliance | Description | Data | Compliance | Description | Data |
|---|---|---|---|---|---|
| No | Ramp Run Slope (%) | 12.2 | N/A | Flare Slope LT (%) | N/A |

**Remove & Replace Curb Ramp With Two New Directional Ramps or Equivalent.**

**R304.2.2, STD 1115**

Total Cost: \$ 6160
