# Access Compliance Report Public Rights-of-Way (Curb Ramps)

Main Street: POONA\_DR Cross Street: LULLABY\_LN Location: SW

ADA ID: RPRK210922142129 Ramp Type: Type 1 - Perpendicular Diagonal Initial Pass/Fail: Fail Overall Compliance: No Severity Score: 32

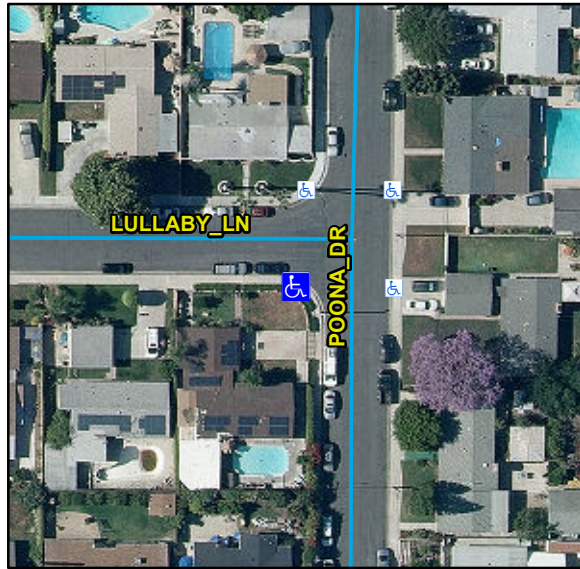
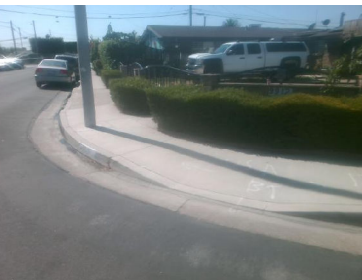
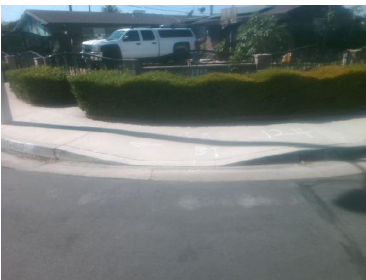
R304.2.2, R304.5.3, STD 1115

| Compliance | Description | Data | Compliance | Description | Data |
|---|---|---|---|---|---|
| No | Ramp Run Slope (%) | 12.6 | N/A | Flare Slope LT (%) | N/A |
| No | Ramp Cross Slope (%) | 2.5 | N/A | Flare Traversable LT | N/A |

Remove & Replace Curb Ramp With Two New Directional Ramps or Equivalent.
