# Access Compliance Report Public Rights-of-Way (Curb Ramps)

Main Street: PERDIDO\_ST Cross Street: HARRIET\_LN Location: NE

ADA ID: RPRK210923111531 Ramp Type: Type 1 - Perpendicular Diagonal Initial Pass/Fail: Fail Overall Compliance: No Severity Score: 32

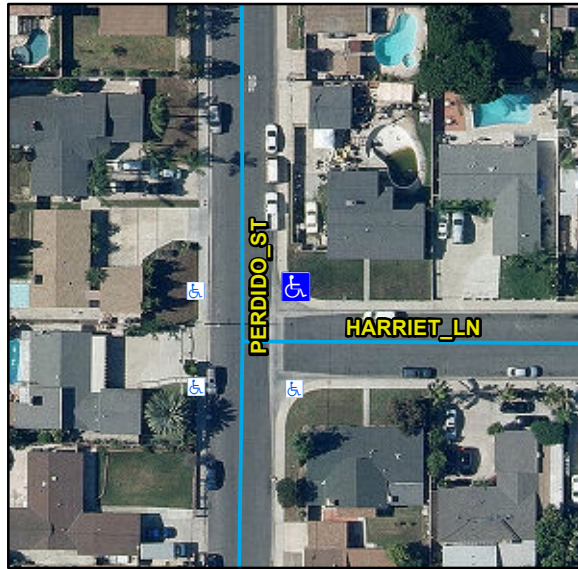
| Compliance | Description | Data | Compliance | Description | Data |
|---|---|---|---|---|---|
| No | Ramp Run Slope (%) | 14.4 | N/A | Flare Slope LT (%) | N/A |
| No | Gutter Lip Height (in) | 1 | | Road Run Slope (%) | 0.5 |

**Remove & Replace Curb Ramp With Two New Directional Ramps or Equivalent. Grind Gutter Lip.**
