# Access Compliance Report Public Rights-of-Way (Curb Ramps)

Main Street: HARRIET\_LN Cross Street: PERDIDO\_ST Location: SE

ADA ID: RPRK210923111802 Ramp Type: Type 1 - Perpendicular Diagonal Initial Pass/Fail: Fail Overall Compliance: No Severity Score: 32

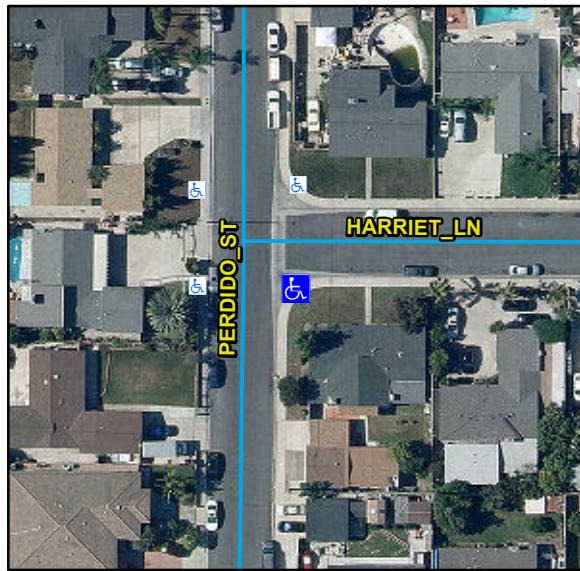
| Compliance | Description | Data | Compliance | Description | Data |
|---|---|---|---|---|---|
| No | Ramp Run Slope (%) | 14.6 | N/A | Flare Slope LT (%) | N/A |
| No | Ramp Cross Slope (%) | 2.3 | N/A | Flare Traversable LT | N/A |
| No | Gutter Lip Height (in) | 0.5 | | Road Run Slope (%) | 0.9 |

**Remove & Replace Curb Ramp With Two New Directional Ramps or Equivalent. Grind Gutter Lip.**

**R204.3, R304.2.2, R304.5.3, R302.7.2, STD 1115**
