# Access Compliance Report Public Rights-of-Way (Curb Ramps)

| Main Street: CHANTICLEER_RD | | Cross Street: PERDIDO_ST | | Location: | SE |
| ADA ID: RPRK210923112241 | Ramp Type:Type 1 - Perpendicular Diagonal Initial Pass/Fail: Fail | | Overall Compliance: No | Severity Score: | 15 |

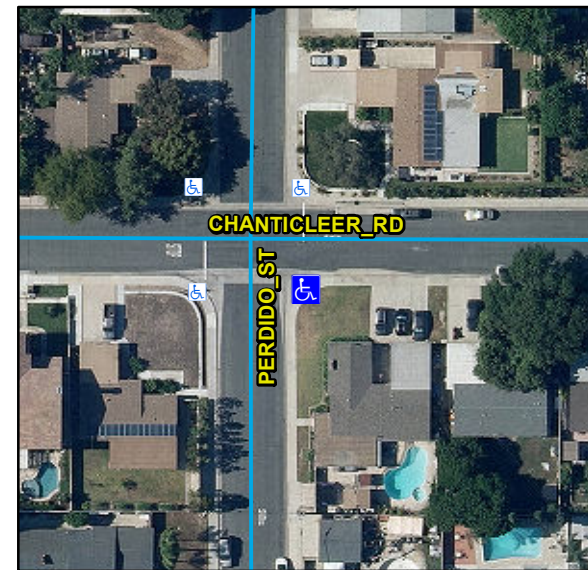
| Compliance | Description | Data | Compliance | Description | Data |
|---|---|---|---|---|---|
| No | Ramp Run Slope (%) | 10.2 | N/A | Flare Slope LT (%) | N/A |
| No | Gutter Lip Height (in) | 0.55 | | Road Run Slope (%) | 2.1 |

**Remove & Replace Curb Ramp With Two New Directional Ramps or Equivalent. Grind Gutter Lip.**

**R204.3, R304.2.2, R302.7.2, STD 1115**
