# Access Compliance Report Public Rights-of-Way (Curb Ramps)

Main Street: PERDIDO\_ST Cross Street: CHANTICLEER\_RD Location: SW

ADA ID: RPRK210923113231 Ramp Type: Type 1 - Perpendicular Diagonal Initial Pass/Fail: Fail Overall Compliance: No Severity Score: 30

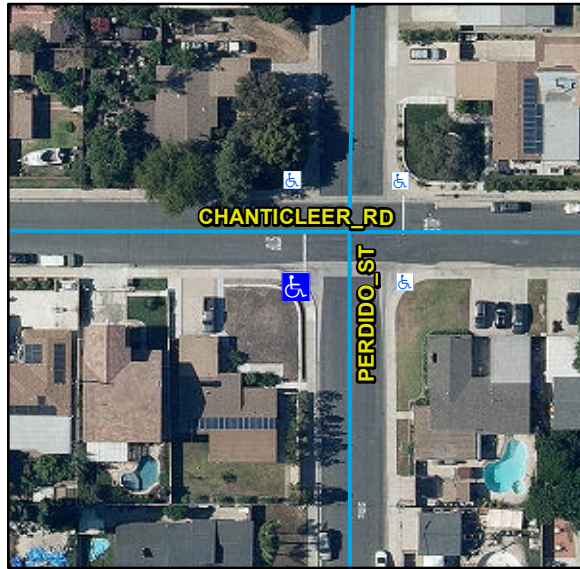
| Compliance | Description | Data | Compliance | Description | Data |
|---|---|---|---|---|---|
| No | Ramp Run Slope (%) | 16.3 | N/A | Flare Slope LT (%) | N/A |
| No | Gutter Lip Height (in) | 0.5 | | Road Run Slope (%) | 0.4 |

**Remove & Replace Curb Ramp With Two New Directional Ramps or Equivalent. Grind Gutter Lip.**

**R204.3, R304.2.2, R302.7.2, STD 1115**
