# Access Compliance Report Public Rights-of-Way (Curb Ramps)

Main Street: CHANTICLEER\_RD Cross Street: RHIEMS\_RD Location: NW

ADA ID: RPRK210923120141 Ramp Type: Type 1 - Perpendicular Diagonal Initial Pass/Fail: Fail Overall Compliance: No Severity Score: 32

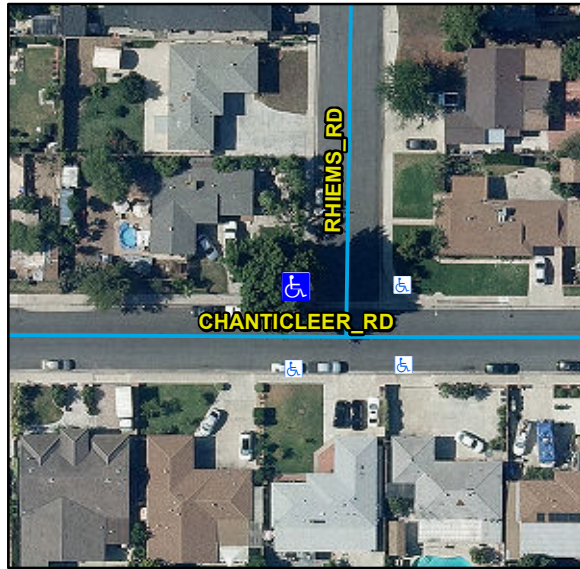
| Compliance | Description | Data | Compliance | Description | Data |
|---|---|---|---|---|---|
| No | Ramp Run Slope (%) | 16.7 | N/A | Flare Slope LT (%) | N/A |
| No | Gutter Lip Height (in) | 0.5 | | Road Run Slope (%) | 0.1 |

Remove & Replace Curb Ramp With Two New Directional Ramps or Equivalent.
