# Access Compliance Report Public Rights-of-Way (Curb Ramps)

Main Street: RHIEMS\_RD Cross Street: CHANTICLEER\_RD Location: NE

ADA ID: RPRK210923120339 Ramp Type: Type 1 - Perpendicular Diagonal Initial Pass/Fail: Fail Overall Compliance: No Severity Score: 30

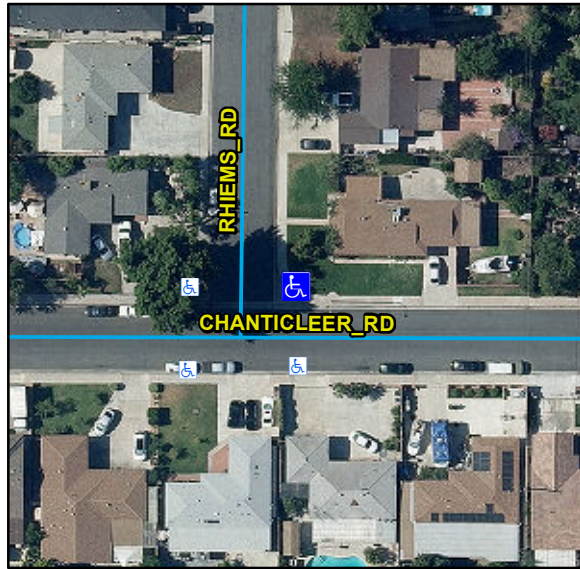
| Compliance | Description | Data | Compliance | Description | Data |
|---|---|---|---|---|---|
| No | Ramp Run Slope (%) | 14.3 | N/A | Flare Slope LT (%) | N/A |
| No | Gutter Lip Height (in) | 0.25 | | Road Run Slope (%) | 1.5 |

Remove & Replace Curb Ramp With Two New Directional Ramps or Equivalent.
