# Access Compliance Report Public Rights-of-Way (Curb Ramps)

Main Street: CHANTICLEER\_RD Cross Street: AMIES\_RD Location: NW

ADA ID: RPRK210923120802 Ramp Type: Type 1 - Perpendicular Diagonal Initial Pass/Fail: Fail Overall Compliance: No Severity Score: 30

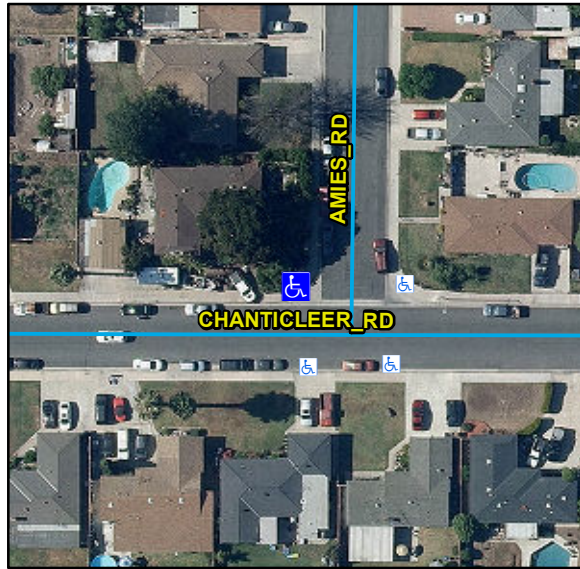
| Compliance | Description | Data | Compliance | Description | Data |
|---|---|---|---|---|---|
| No | Ramp Run Slope (%) | 16.3 | N/A | Flare Slope LT (%) | N/A |
| No | Gutter Lip Height (in) | 0.5 | | Road Run Slope (%) | 0.8 |

**Remove & Replace Curb Ramp With Two New Directional Ramps or Equivalent.**

**R304.2.2, R204.3, R302.7.2, STD 1115**
