# Access Compliance Report Public Rights-of-Way (Curb Ramps)

Main Street: AMIES\_RD Cross Street: CHANTICLEER\_RD Location: NE

ADA ID: RPRK210923120953 Ramp Type: Type 1 - Perpendicular Diagonal Initial Pass/Fail: Fail Overall Compliance: No Severity Score: 16

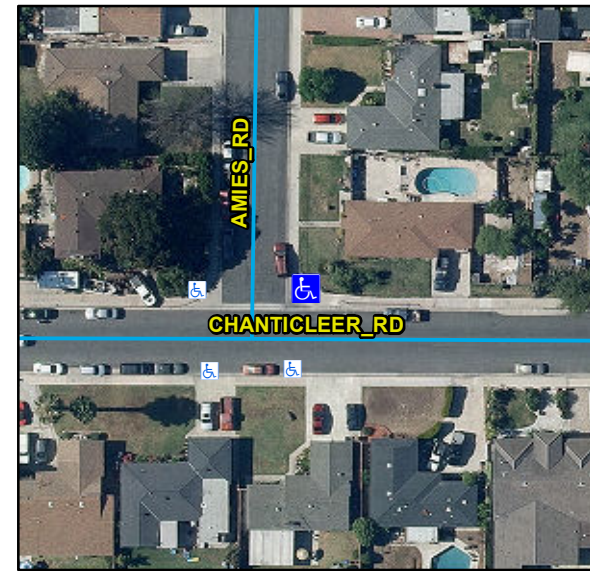
| Compliance | Description | Data | Compliance | Description | Data |
|---|---|---|---|---|---|
| No | Ramp Run Slope (%) | 10.7 | N/A | Flare Slope LT (%) | N/A |
| No | Gutter Lip Height (in) | 0.25 | | Road Run Slope (%) | 0.6 |

Possible Solutions:  
**Remove & Replace Curb Ramp With Two New Directional Ramps or Equivalent.**

OC Std/PROW:  
**R304.2.2, R204.3, R302.7.2, STD 1115**

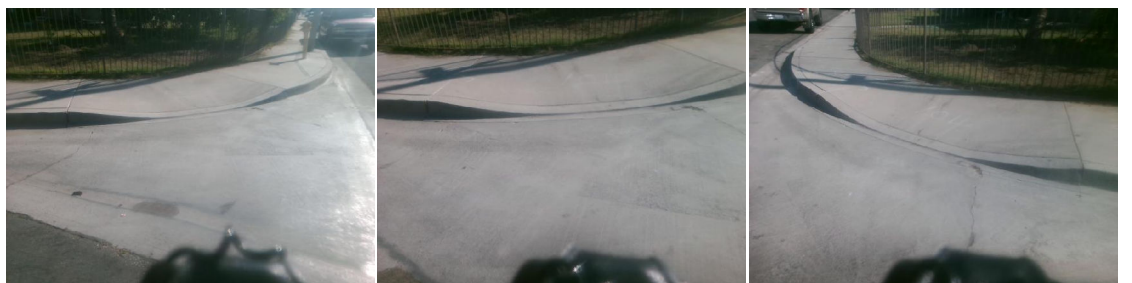
| Compliance | Description | Data | Compliance | Description | Data |
|---|---|---|---|---|---|
| N/A | Ramp Length (in) | 48 | N/A | Flare Type LT | |
| Yes | Ramp Width (in) | 48 | | | N/A |
| Yes | Ramp Cross Slope (%) | 1.3 | N/A | Flare Traversable LT | N/A |
