# Access Compliance Report Public Rights-of-Way (Curb Ramps)

**Main Street:** GILBERT\_ST      **Cross Street:** CHANTICLEER\_RD      **Location:** NW

**ADA ID:** RPRK210923123226      **Ramp Type:** Type 4 - Parallel      **Initial Pass/Fail:** Pass      **Overall Compliance:** No      **Severity Score:** 6

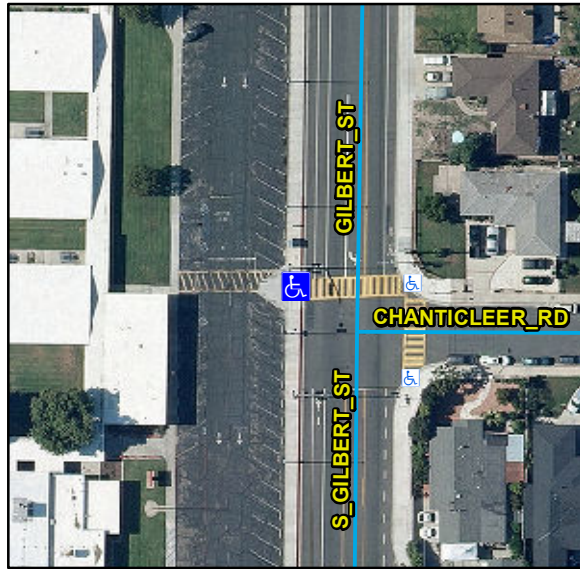
Compliance	Description	Data	Compliance	Description	Data
N/A	Ramp Length LT (in)	95	N/A	Ramp Length RT (in)	100
Yes	Ramp Width LT (in)	69	Yes	Ramp Width RT (in)	70
Yes	Ramp Run Slope LT (%)	7.9	Yes	Ramp Run Slope RT (%)	5.1
Yes	Ramp Cross Slope LT (%)	0	Yes	Ramp Cross Slope RT (%)	2
N/A	Landing Present	Yes	Yes	DWS Provided	Yes
N/A	Landing Length (in)	100	Yes	DWS Contrast	Yes
Yes	Landing Width (in)	48	Yes	DWS Length (in)	36
No	Landing Run Slope (%)	7.6	Yes	DWS Full Width	Yes
Yes	Landing Cross Slope (%)	1.3		DWS Offset Type	Single
N/A	Landing Movement Obstructed?	No	Yes	DWS Offset Left (in)	0
	Landing Movement Type	Curb	Yes	DWS Offset Right (in)	N/A
N/A	Landing Shared	No			
N/A	Clear Space	N/A			
N/A	Clear Space To Crosswalk (in)	N/A			
N/A	Marked Crosswalk 1	Yes	N/A	Marked Crosswalk 2	N/A
	Crossing 1 Direction	E		Crossing 2 Direction	N/A
	Marked Crosswalk 1 Width (in)	135		Marked Crosswalk 2 Width (in)	N/A
Yes	Ramp Inside Crosswalk 1	Yes	N/A	Ramp Inside Crosswalk 2	N/A

Crossing 1 Slope (%)	4.7		Crossing 2 Slope (%)	N/A
	Crossing 1 Cross Slope (%)	0.2		Crossing 2 Cross Slope (%)	N/A
Yes	Gutter Ponding	No	Yes	Curb Slope	7.6
Yes	Gutter Lip Height (in)	0		Road Run Slope (%)	N/A
Yes	Gutter Run Slope (%)	0.4		Road Cross Slope (%)	N/A
No	Gutter Cross Slope (%)	5.6	Yes	Perpendicular Joint Present	Yes
Yes	Overall Surface Condition	Acceptable			
	Cross Gutter Present?	No		Spandrel Present?	No
	Replace Cross Gutter?	N/A		Replace Spandrel?	N/A

**Possible Solutions:**  
**Remove & Replace Landing. Remove & Replace Gutter.**
