# Access Compliance Report Public Rights-of-Way (Curb Ramps)

Main Street: S\_GILBERT\_ST Cross Street: HARRIET\_LN Location: N

ADA ID: RPRK210923125228 Ramp Type: Type 1 - Perpendicular Diagonal Initial Pass/Fail: Fail Overall Compliance: No Severity Score: 15

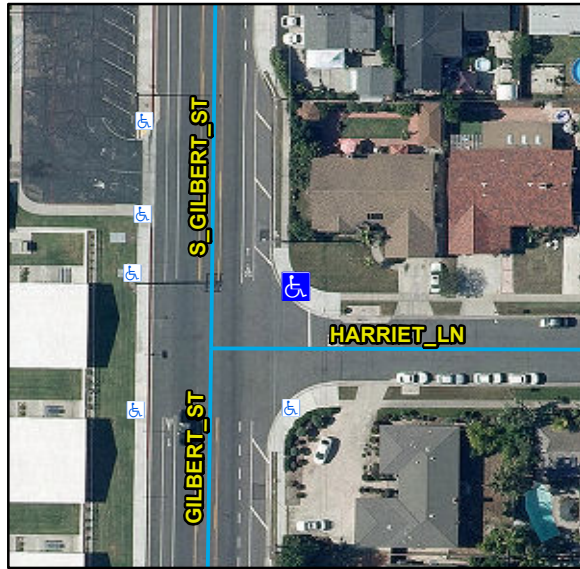
| Compliance | Description | Data | Compliance | Description | Data |
|---|---|---|---|---|---|
| No | Ramp Run Slope (%) | 9.4 | N/A | Flare Slope LT (%) | N/A |

Remove & Replace Curb Ramp With Two New Directional Ramps or Equivalent.

R304.2.2, STD 1115
