# Access Compliance Report Public Rights-of-Way (Curb Ramps)

Main Street: N/A Cross Street: GILBERT\_ST Location: E

ADA ID: RPRK210923125859 Ramp Type: Type 6 - Directional 1 Initial Pass/Fail: Pass Overall Compliance: No Severity Score: 0

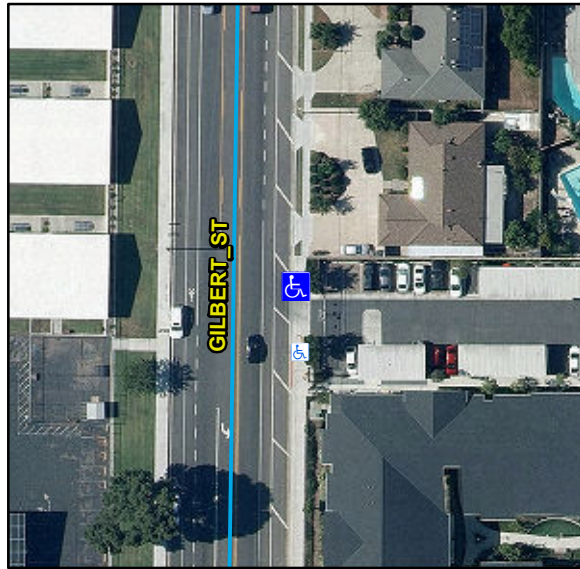
| Compliance | Description | Data | Compliance | Description | Data |
|---|---|---|---|---|---|
| N/A | Ramp Length (in) | 91 | No | Flare Type LT | |
| Yes | Ramp Width (in) | 48 | | | Curbed1 |
| Yes | Ramp Run Slope (%) | 7.6 | N/A | Flare Slope LT (%) | N/A |
| Yes | Ramp Cross Slope (%) | 1.3 | N/A | Flare Traversable LT | N/A |
| No | Grade Break | No | Yes | Flare Type RT | |

Remove & Replace Entire Ramp.

R304.5.2, R304.2.3, STD 1115

\$ 3080
