Access Compliance Report Public Rights-of-Way (Curb Ramps)

Main Street: GILBERT ST **Cross Street: CERRITOS AVE** Location: SW

ADA ID: RPRK210923132628 Ramp Type:Type 1 - Perpendicular Diagonal Initial Pass/Fail: Pass **Overall Compliance: No Severity Score:**

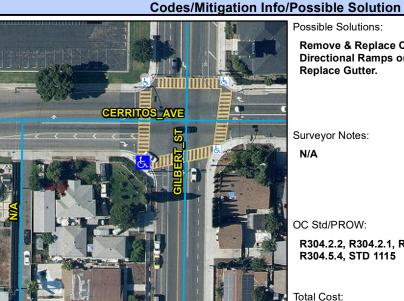
Field Measurements/Component Compliance								
	Compliance Description		Data	Com	pliance	Description	Data	
	N/A	Ramp Length (in)	80	N/A	Flare Ty	pe LT		
	Yes	Ramp Width (in)	48				Sloped	
	Yes	Ramp Run Slope (%)	7	N/A	Flare Slo	ppe LT (%)	8	
	Yes	Ramp Cross Slope (%)	0.4	N/A	Flare Tra	aversable LT	No	
	N/A	Landing Present	Yes	N/A	Flare Ty	pe RT		
	N/A	Landing Length (in)	30				Sloped	
	Yes	Landing Width (in)	48	N/A	Flare Slo	ppe RT (%)	8.9	
	No	Landing Run Slope (%)	2.2	N/A	Flare Tra	aversable RT	No	
	Yes	Landing Cross Slope (%)	0.3	Yes	DWS Pr	ovided	Yes	
	N/A	Landing Movement Obstructed?	No	Yes	DWS Co	ontrast	Yes	
		Landing Movement Type	N/A	Yes	DWS Le	ngth (in)	36	
	N/A	Landing Shared	No	Yes	DWS Fu	ll Width	Yes	
	Yes	Clear Space	Yes	Yes	DWS Of	fset Left (in)	0	
	Yes	Clear Space To Crosswalk (in)	48	Yes	DWS Of	fset Right (in)	N/A	
2	N/A	Marked Crosswalk 1	Yes	N/A	Marked	Crosswalk 2	Yes	
		Crossing 1 Direction	Е		Crossing	2 Direction	N

Т		Marked Crosswalk 1 Width (in)	150		Marked	Crosswalk 2 Width (in)	150	
al	Yes	Ramp Inside Crosswalk 1	Yes	Yes	Ramp In	side Crosswalk 2	Yes	
Έ		Crossing 1 Slope (%)	4.2		Crossing	g 2 Slope (%)	1.7	
al		Crossing 1 Cross Slope (%)	1.2		Crossing	g 2 Cross Slope (%)	1.5	
	Yes	Gutter Ponding	No	No	Curb Slo	ppe	5.6	
	Yes	Gutter Lip Height (in)	0		Road R	un Slope (%)	0.2	
	No	Gutter Run Slope (%)	7		Road Cr	oss Slope (%)	4.4	
ta	Yes	Gutter Cross Slope (%)	1.2					
lo	Yes	Overall Surface Condition: Accep	otable	Yes	Perp Joi	nt Present	Yes	
Ά		Cross Gutter Present?	No		Spandre	I Present?	No	
A		Replace Cross Gutter?	N/A		Replace	Spandrel?	N/A

Remove & Replace Curb Ramp With Two New Directional Ramps or Equivalent. Remove & Replace Gutter.
