# Access Compliance Report Public Rights-of-Way (Curb Ramps)

Main Street: CHANTICLEER\_RD Cross Street: BOUVAIS\_RD Location: NW

ADA ID: RPRK210923134137 Ramp Type: Type 1 - Perpendicular Diagonal Initial Pass/Fail: Fail Overall Compliance: No Severity Score: 32

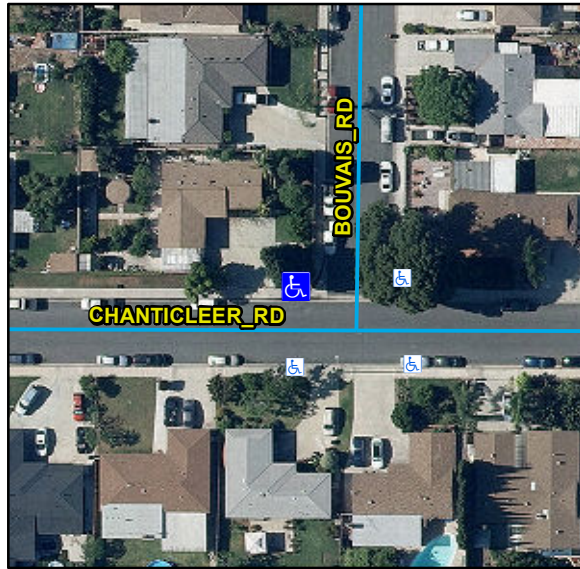
| Compliance | Description | Data | Compliance | Description | Data |
|---|---|---|---|---|---|
| No | Ramp Run Slope (%) | 14.9 | N/A | Flare Slope LT (%) | N/A |
| No | Gutter Lip Height (in) | 0.25 | | Road Run Slope (%) | 0.2 |

Remove & Replace Curb Ramp With Two New Directional Ramps or Equivalent.

R304.2.2, R204.3, R302.7.2, STD 1115
