# Access Compliance Report Public Rights-of-Way (Curb Ramps)

Main Street: BOUVAIS\_RD Cross Street: CHANTICLEER\_RD Location: NE

ADA ID: RPRK210923134405 Ramp Type: Type 1 - Perpendicular Diagonal Initial Pass/Fail: Fail Overall Compliance: No Severity Score: 32

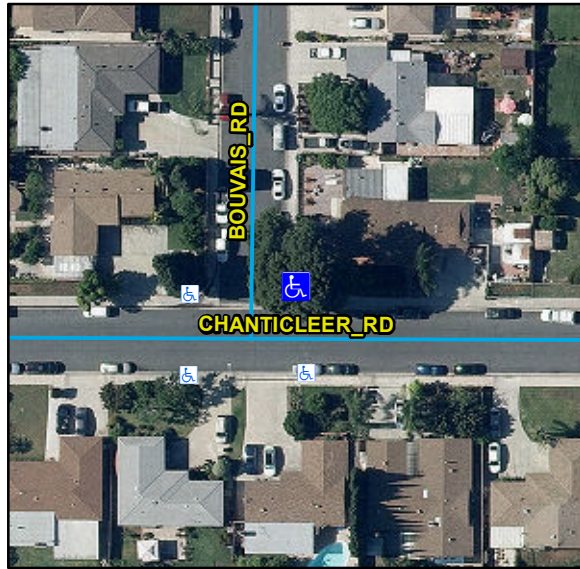
| Compliance | Description | Data | Compliance | Description | Data |
|---|---|---|---|---|---|
| No | Ramp Run Slope (%) | 13.6 | N/A | Flare Slope LT (%) | N/A |
| No | Ramp Cross Slope (%) | 2.4 | N/A | Flare Traversable LT | N/A |
| No | Gutter Lip Height (in) | 0.25 | | Road Run Slope (%) | 0.8 |

**Remove & Replace Curb Ramp With Two New Directional Ramps or Equivalent. Grind Gutter Lip.**

**R204.3, R304.2.2, R304.5.3, R302.7.2, STD 1115**
