# Access Compliance Report Public Rights-of-Way (Curb Ramps)

Main Street: D\_ESTE\_DR Cross Street: CHANTICLEER\_RD Location: NE

ADA ID: RPRK210923135100 Ramp Type: Type 1 - Perpendicular Diagonal Initial Pass/Fail: Fail Overall Compliance: No Severity Score: 32

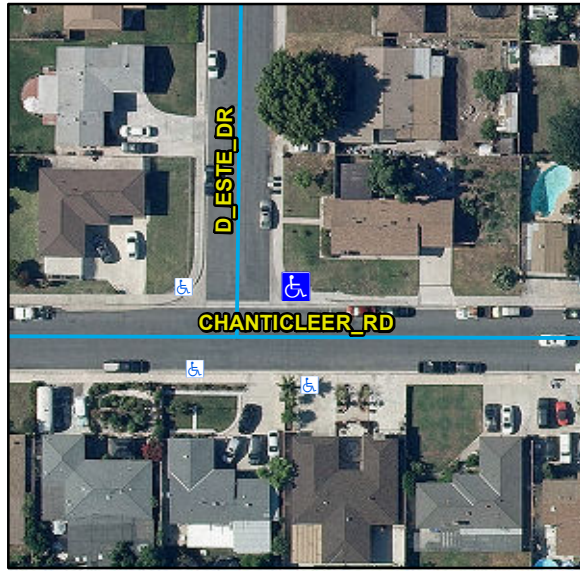
| Compliance | Description | Data | Compliance | Description | Data |
|---|---|---|---|---|---|
| No | Ramp Run Slope (%) | 12.1 | N/A | Flare Slope LT (%) | N/A |
| No | Gutter Lip Height (in) | 0.25 | | Road Run Slope (%) | 0.9 |

**Remove & Replace Curb Ramp With Two New Directional Ramps or Equivalent.**

**R304.2.2, R204.3, R302.7.2, STD 1115**
