# Access Compliance Report Public Rights-of-Way (Curb Ramps)

Main Street: CHANTICLEER\_RD Cross Street: D\_ESTE\_DR Location: NW

ADA ID: RPRK210923135255 Ramp Type: Type 1 - Perpendicular Diagonal Initial Pass/Fail: Fail Overall Compliance: No Severity Score: 30

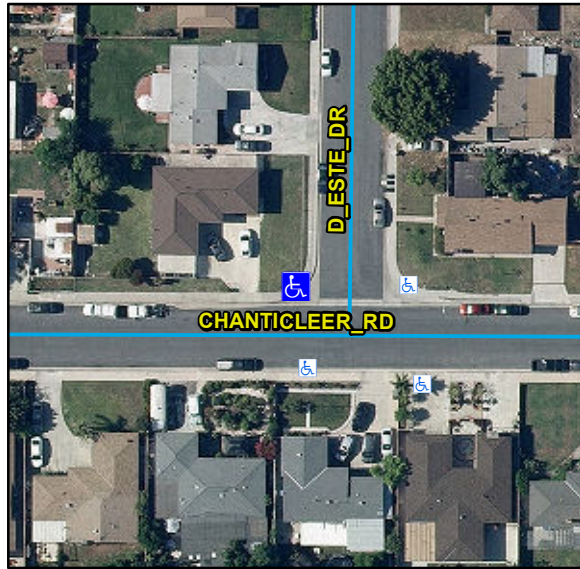
| Compliance | Description | Data | Compliance | Description | Data |
|---|---|---|---|---|---|
| No | Ramp Run Slope (%) | 16 | N/A | Flare Slope LT (%) | N/A |
| No | Gutter Lip Height (in) | 0.25 | | Road Run Slope (%) | 0.7 |

Remove & Replace Curb Ramp With Two New Directional Ramps or Equivalent.

R304.2.2, R204.3, R302.7.2, STD 1115
