# Access Compliance Report Public Rights-of-Way (Curb Ramps)

Main Street: D\_ESTE\_DR Cross Street: GUINIDA\_LN Location: NE

ADA ID: RPRK210923140001 Ramp Type: Type 1 - Perpendicular Diagonal Initial Pass/Fail: Pass Overall Compliance: No Severity Score: 0

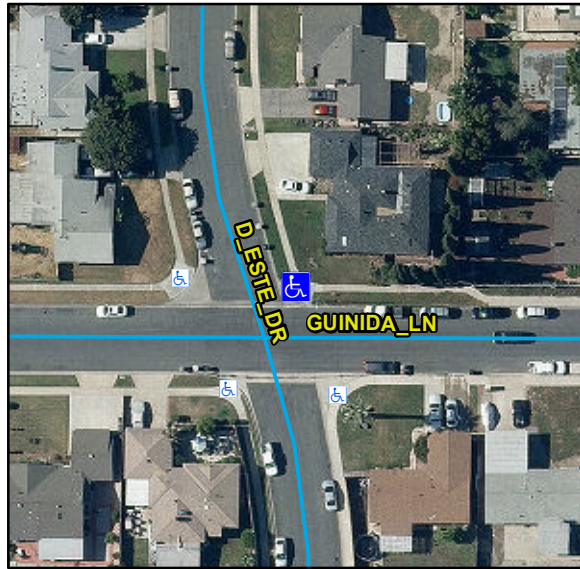
| Compliance | Description | Data | Compliance | Description | Data |
|---|---|---|---|---|---|
| Yes | Gutter Ponding | No | No | Curb Slope | 5.3 |
| No | Gutter Cross Slope (%) | 4.7 | | | |

**Remove & Replace Curb Ramp With Two New Directional Ramps or Equivalent. Remove & Replace Gutter.**

**R304.2.2, R304.2.1, R304.5.3, STD 1115**
