# Access Compliance Report

## Public Rights-of-Way

### (Curb Ramps)

Main Street: **GUINIDA\_LN** Cross Street: **D\_ESTE\_DR** Location: **NW**

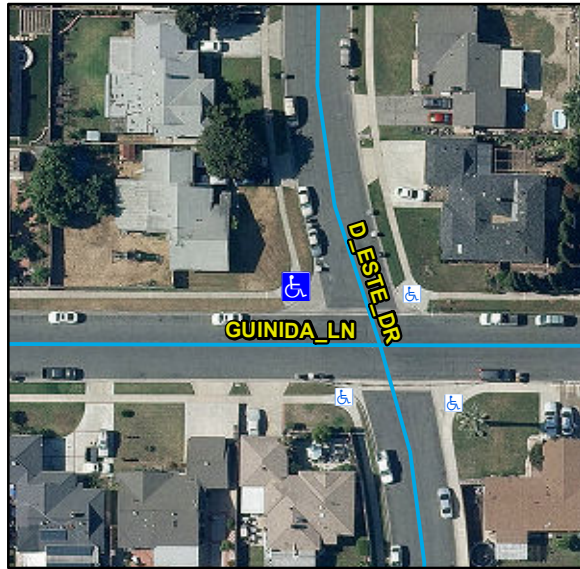
ADA ID: **RPRK210923140427** Ramp Type: **Type 1 - Perpendicular Diagonal Initial Pass/Fail: Pass** Overall Compliance: **No** Severity Score: **0**

| Compliance | Description | Data | Compliance | Description | Data |
|---|---|---|---|---|---|
| <b>No</b> | Gutter Cross Slope (%) | <b>2.4</b> | | | |

Possible Solutions:

**Remove & Replace Gutter.**

**R304.5.3, STD 1115**

Total Cost: \$ **252**
