# Access Compliance Report

## Public Rights-of-Way

### (Curb Ramps)

Main Street: **D\_ESTE\_DR** Cross Street: **GUINIDA\_LN** Location: **SW**

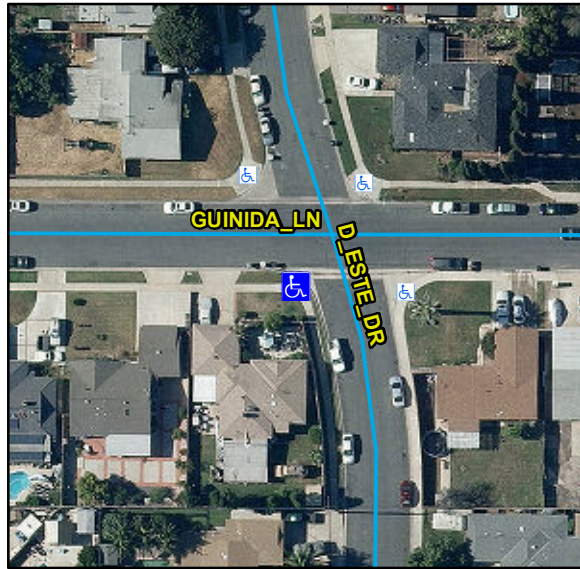
ADA ID: **RPRK210923140736** Ramp Type: **Type 1 - Perpendicular Diagonal Initial Pass/Fail: Pass** Overall Compliance: **No** Severity Score: **0**

| Compliance | Description | Data | Compliance | Description | Data |
|---|---|---|---|---|---|
| N/A | Landing Movement Obstructed? | Yes | Yes | DWS Contrast | Yes |
| | Landing Movement Type | Curb | Yes | DWS Length (in) | 36 |

Possible Solutions:

**Remove & Replace Landing.**

**R304.2.1, STD 1115**

**\$ 531**
