# Access Compliance Report Public Rights-of-Way (Curb Ramps)

Main Street: ANTIGUA\_ST Cross Street: CHANTICLEER\_RD Location: NE

ADA ID: RPRK210923142510 Ramp Type: Type 1 - Perpendicular Diagonal Initial Pass/Fail: Fail Overall Compliance: No Severity Score: 32

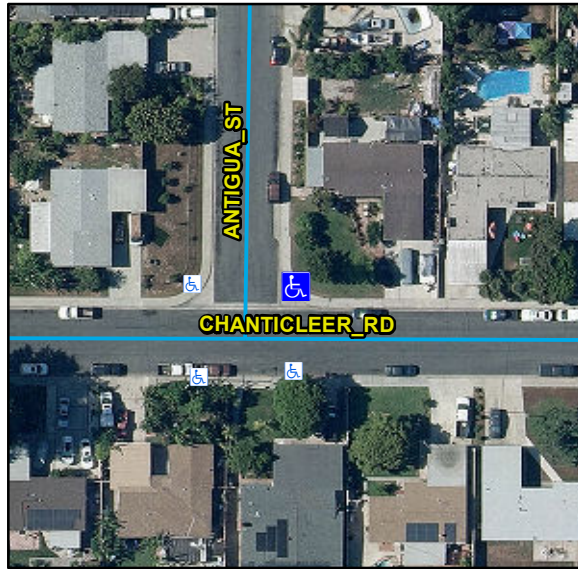
| Compliance | Description | Data | Compliance | Description | Data |
|---|---|---|---|---|---|
| No | Ramp Run Slope (%) | 13.3 | N/A | Flare Slope LT (%) | N/A |
| No | Ramp Cross Slope (%) | 3.1 | N/A | Flare Traversable LT | N/A |
| No | Gutter Lip Height (in) | 0.5 | | Road Run Slope (%) | 0.3 |

**Remove & Replace Curb Ramp With Two New Directional Ramps or Equivalent. Grind Gutter Lip.**

**R204.3, R304.2.2, R304.5.3, R302.7.2, STD 1115**
