# Access Compliance Report Public Rights-of-Way (Curb Ramps)

Main Street: CHANTICLEER\_RD Cross Street: ANTIGUA\_ST Location: NW

ADA ID: RPRK210923142753 Ramp Type: Type 1 - Perpendicular Diagonal Initial Pass/Fail: Fail Overall Compliance: No Severity Score: 32

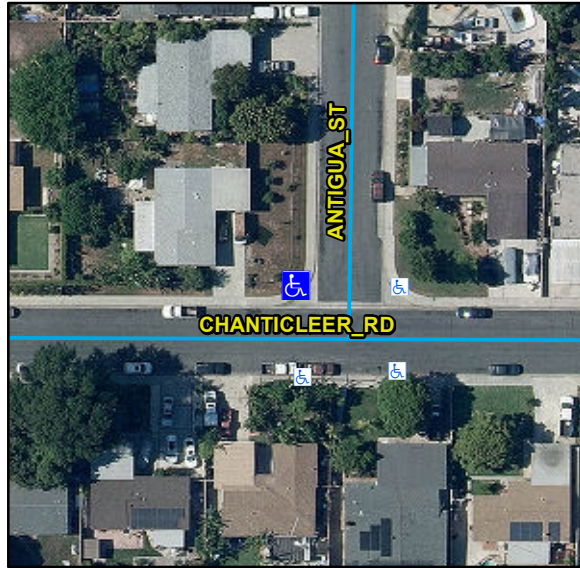
| Compliance | Description | Data | Compliance | Description | Data |
|---|---|---|---|---|---|
| No | Ramp Run Slope (%) | 15 | N/A | Flare Slope LT (%) | N/A |
| No | Ramp Cross Slope (%) | 3 | N/A | Flare Traversable LT | N/A |
| No | Gutter Lip Height (in) | 0.25 | | Road Run Slope (%) | 0.6 |

**Remove & Replace Curb Ramp With Two New Directional Ramps or Equivalent. Grind Gutter Lip.**

**R204.3, R304.2.2, R304.5.3, R302.7.2, STD 1115**
