# Access Compliance Report Public Rights-of-Way (Curb Ramps)

Main Street: HEARTH\_LN Cross Street: BIENVILLE\_AVE Location: SW

ADA ID: RPRK210923163249 Ramp Type: Type 1 - Perpendicular Diagonal Initial Pass/Fail: Fail Overall Compliance: No Severity Score: 30

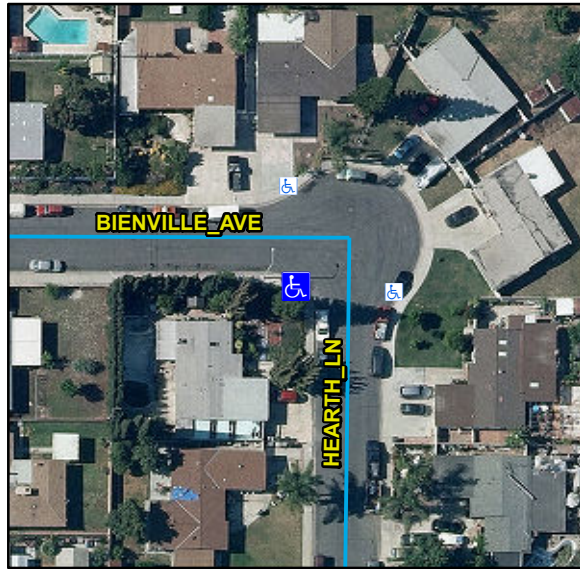
| Compliance | Description | Data | Compliance | Description | Data |
|---|---|---|---|---|---|
| No | Ramp Run Slope (%) | 14.3 | N/A | Flare Slope LT (%) | N/A |
| No | Gutter Lip Height (in) | 0.5 | | Road Run Slope (%) | 0.3 |

**Remove & Replace Curb Ramp With Two New Directional Ramps or Equivalent. Grind Gutter Lip.**

**R204.3, R304.2.2, R302.7.2, STD 1115**
